**Subject: Mesa I Mines, Preliminary Assessment Report**  
**EPA ID NO.: NND983466772**

Site Name: Mesa I Mines

**August 2008**

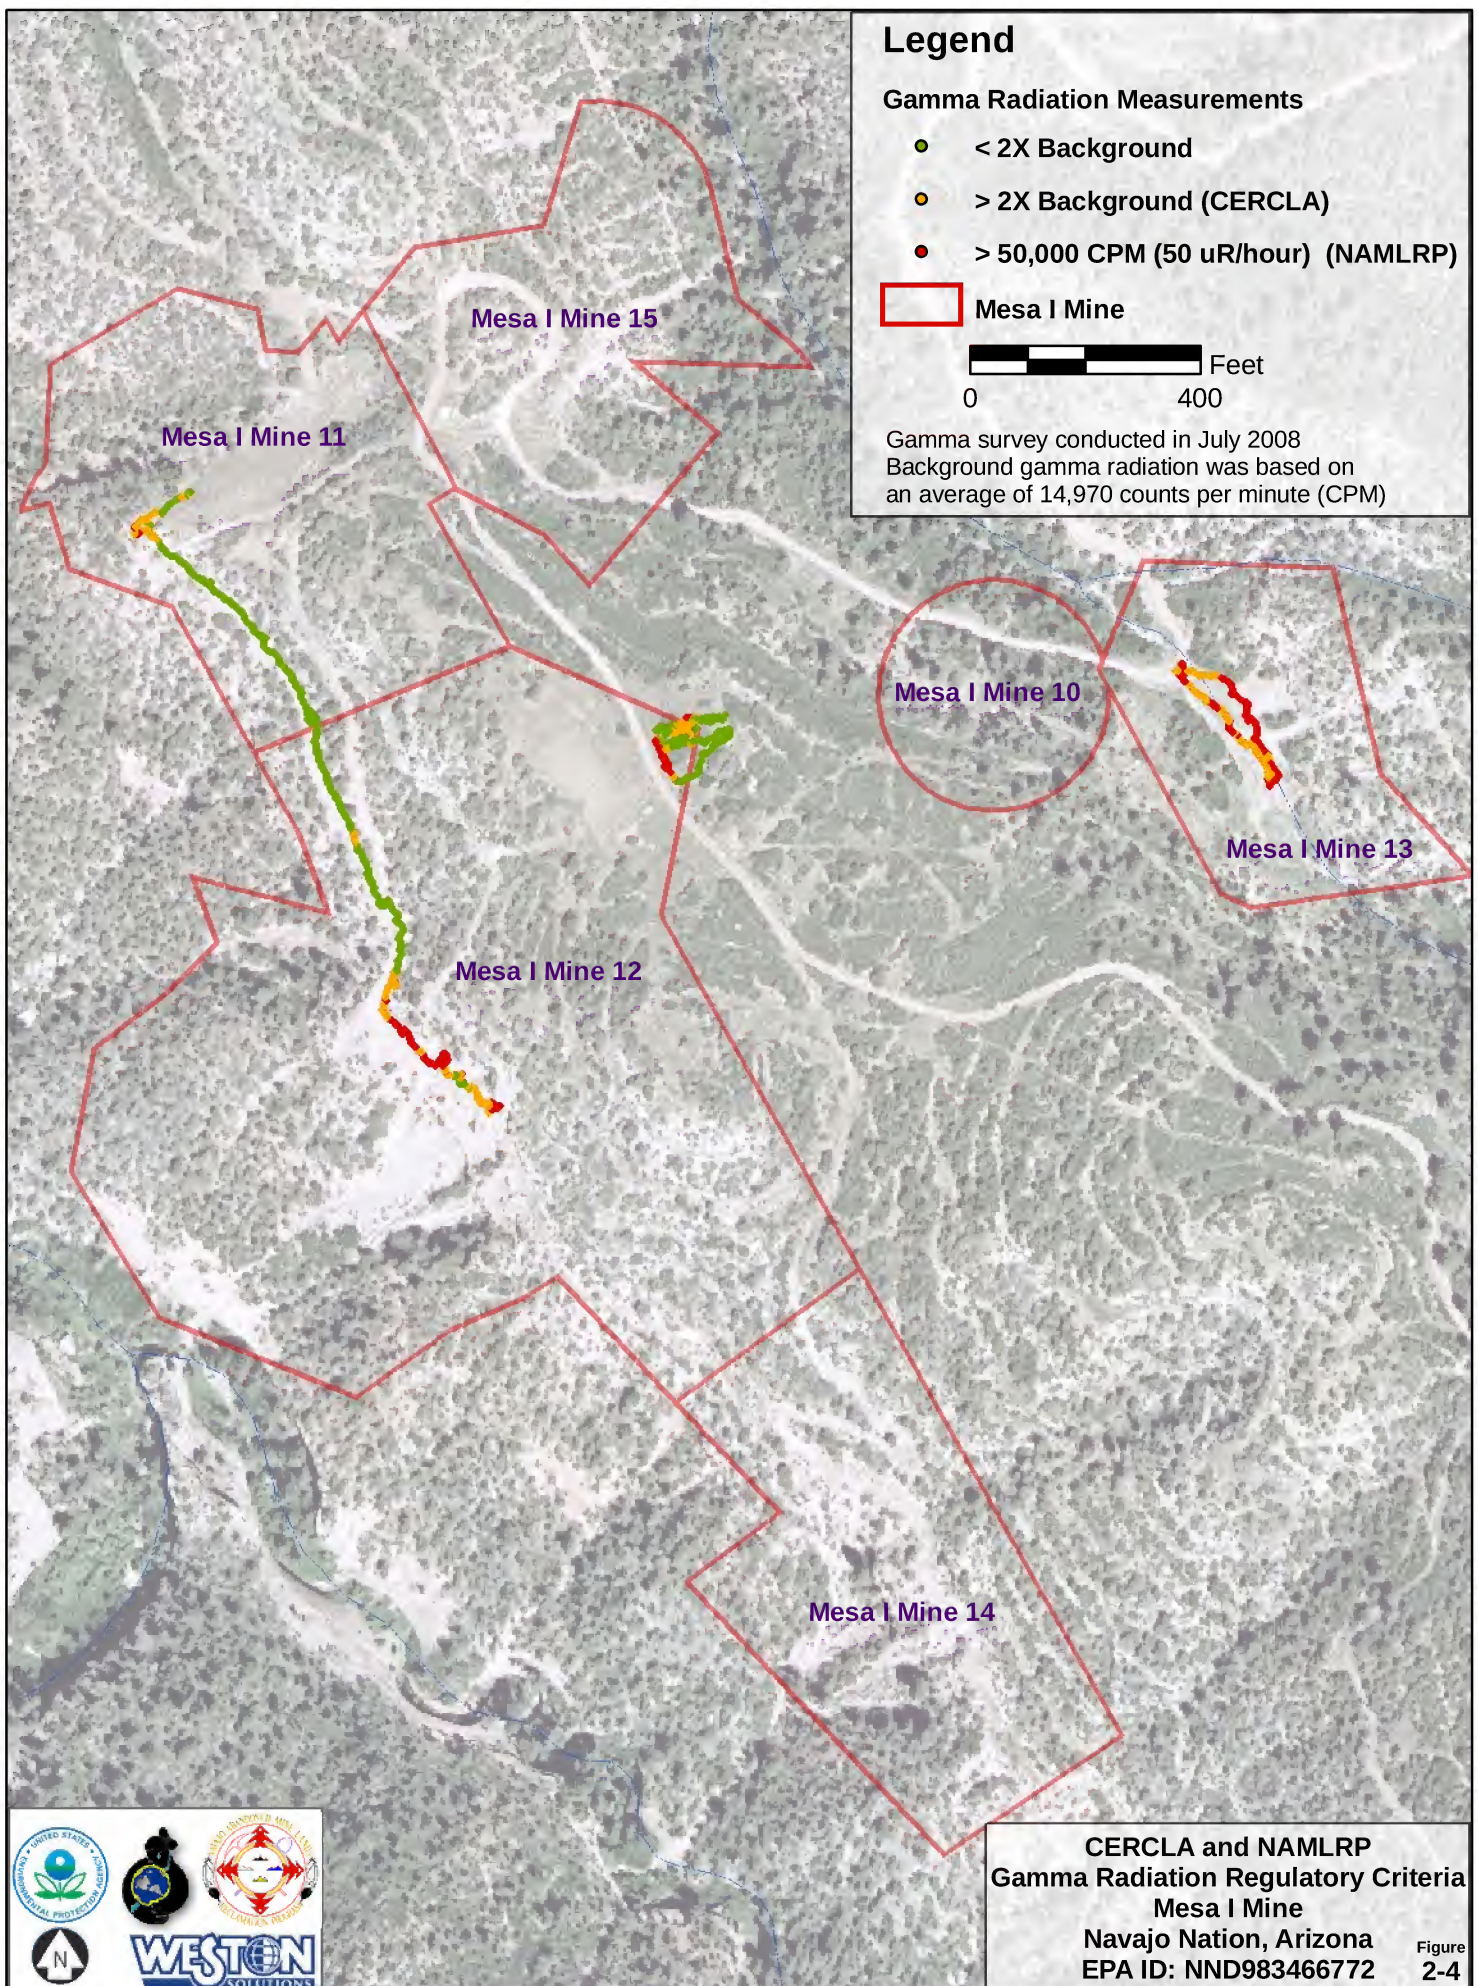
Figure  
2-4

Gamma survey conducted in July 2008  
Background gamma radiation was based on  
an average of 14,970 counts per minute (CPM)

CERCLA and NAMLRP  
Gamma Radiation Regulatory Criteria  
Mesa I Mine  
Navajo Nation, Arizona  
EPA ID: NND983466772

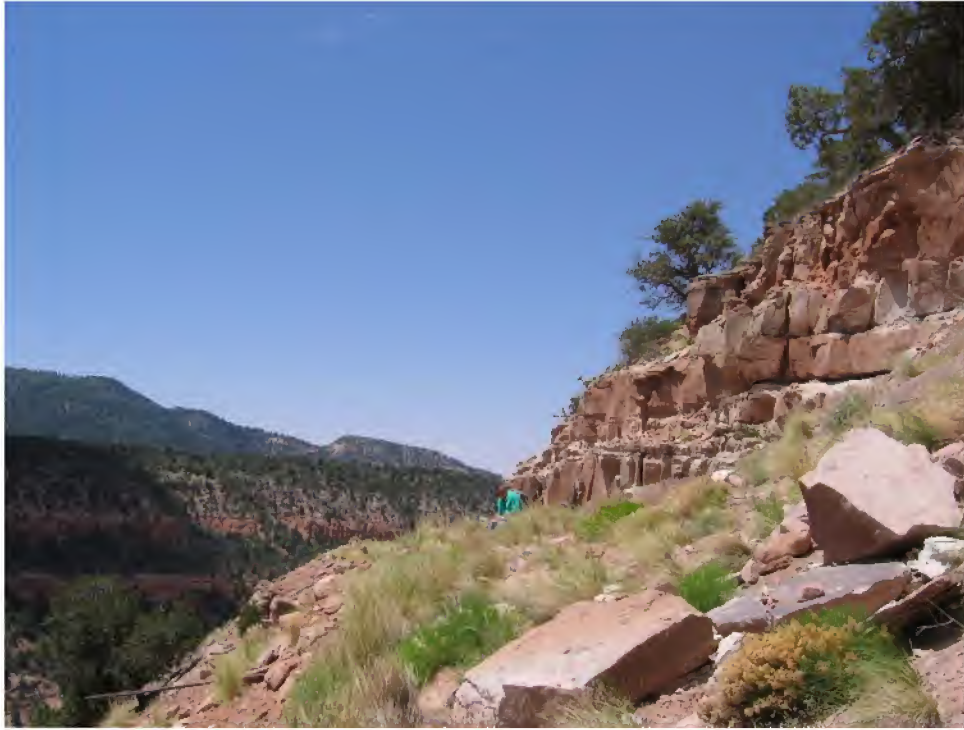
**Photo 3:** Mine tailings at Mine 12 mesa ridge.

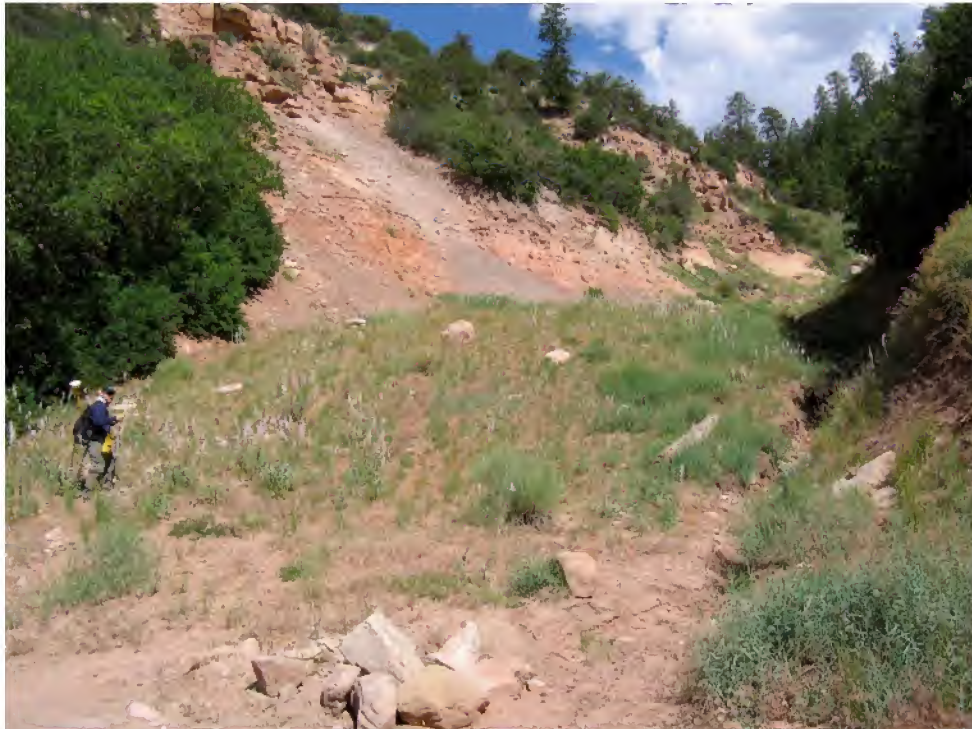
**Photo 4:** Area reclaimed by the Navajo Abandoned Mines Reclamation Program at Mine 13.

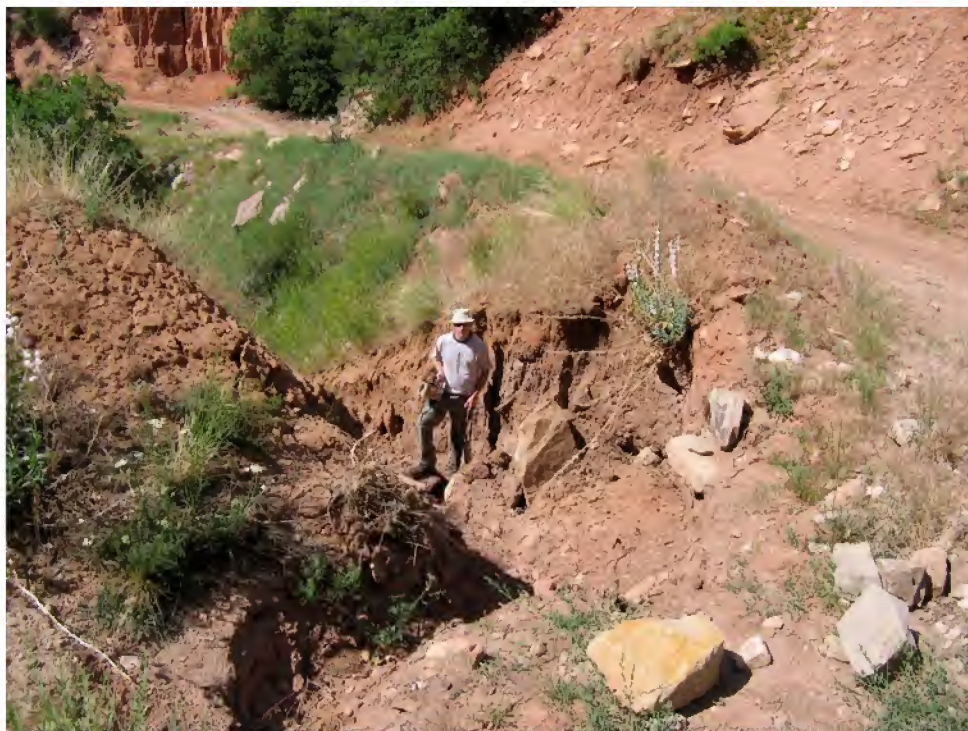
**Photo 5:** A WESTON employee collects gamma radiation readings in the drainage from the reclaimed portion of Mine 13.

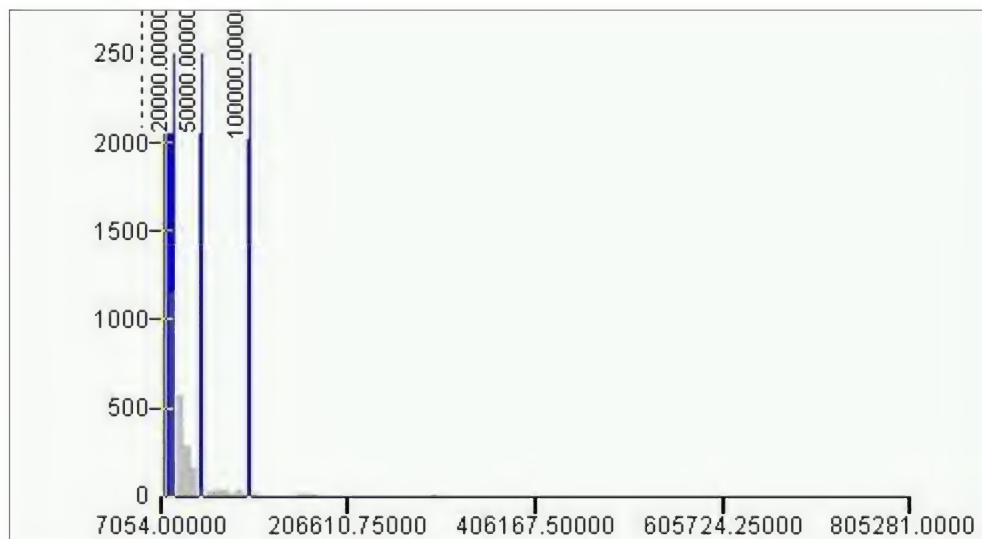
The following chart and statistics were generated by ESRI ArcGIS 9.3.1, and show the general distribution of the site gamma radiation measurements. The horizontal X axis represents the gamma radiation reading levels in cpm (lowest levels to the left). The vertical Y axis represents the frequency of each gamma radiation level.

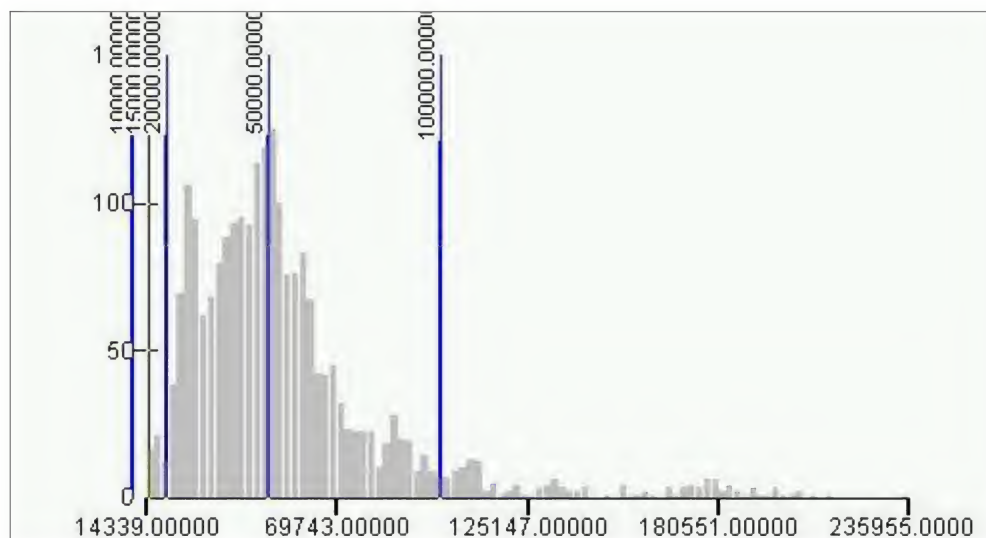
The following chart and statistics were generated by ESRI ArcGIS 9.3.1, and show the general distribution of the site gamma radiation measurements. The horizontal X axis represents the gamma radiation reading levels in cpm (lowest levels to the left). The vertical Y axis represents the frequency of each gamma radiation level.

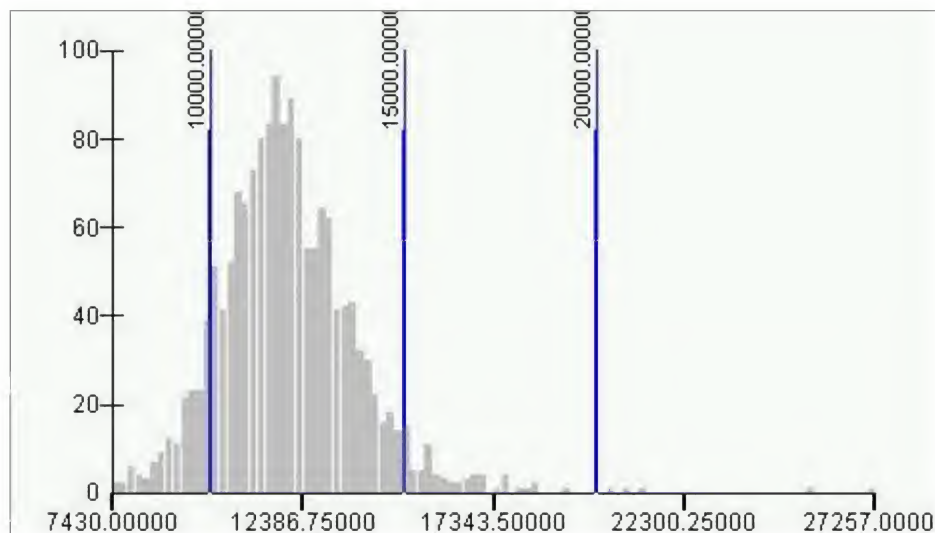
The following chart and statistics were generated by ESRI ArcGIS 9.3.1, and show the general distribution of the site gamma radiation measurements. The horizontal X axis represents the gamma radiation reading levels in cpm (lowest levels to the left). The vertical Y axis represents the frequency of each gamma radiation level.

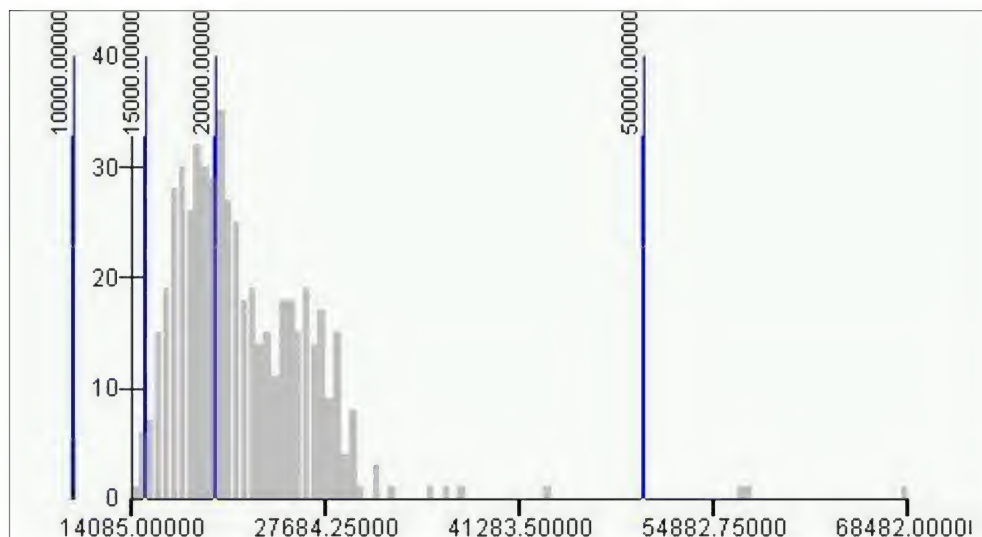
The following chart and statistics were generated by ESRI ArcGIS 9.3.1, and show the general distribution of the site gamma radiation measurements. The horizontal X axis represents the gamma radiation reading levels in cpm (lowest levels to the left). The vertical Y axis represents the frequency of each gamma radiation level.

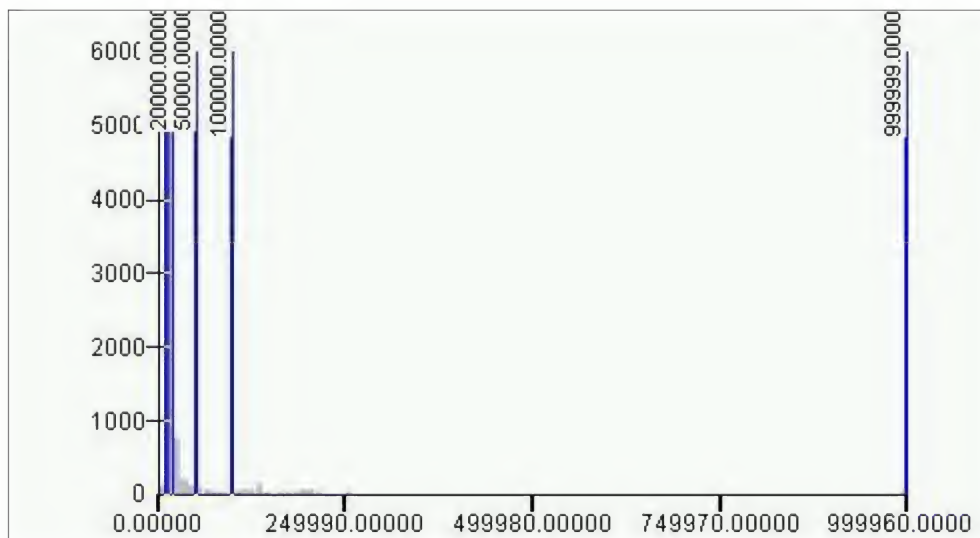
The following chart and statistics were generated by ESRI ArcGIS 9.3.1, and show the general distribution of the site gamma radiation measurements. The horizontal X axis represents the gamma radiation reading levels in cpm (lowest levels to the left). The vertical Y axis represents the frequency of each gamma radiation level.

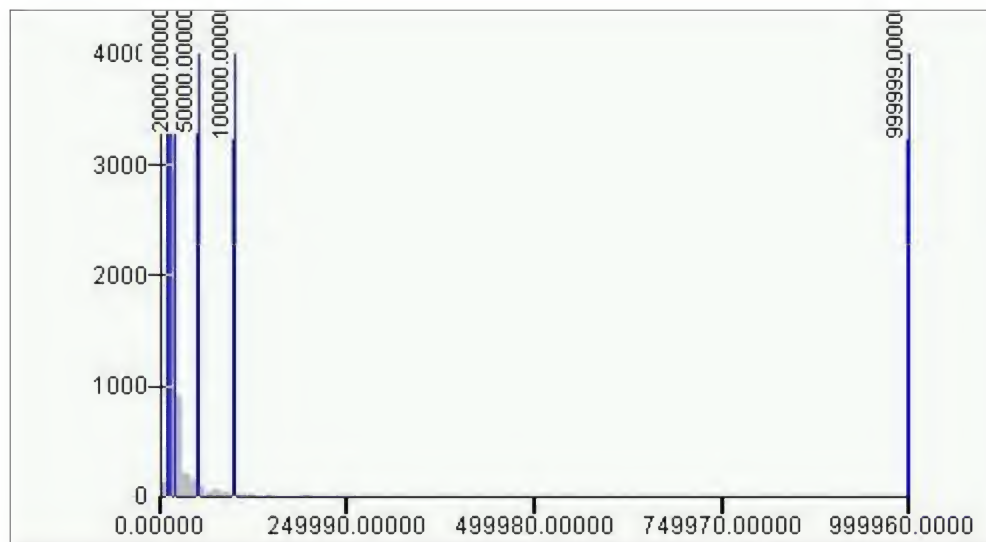
The following chart and statistics were generated by ESRI ArcGIS 9.3.1, and show the general distribution of the site gamma radiation measurements. The horizontal X axis represents the gamma radiation reading levels in cpm (lowest levels to the left). The vertical Y axis represents the frequency of each gamma radiation level.

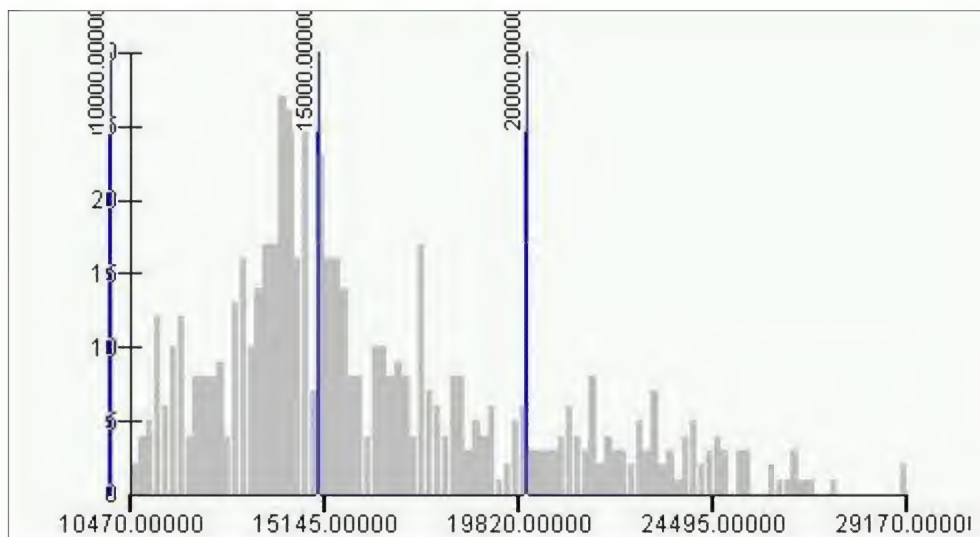
The following chart and statistics were generated by ESRI ArcGIS 9.3.1, and show the general distribution of the site gamma radiation measurements. The horizontal X axis represents the gamma radiation reading levels in cpm (lowest levels to the left). The vertical Y axis represents the frequency of each gamma radiation level.

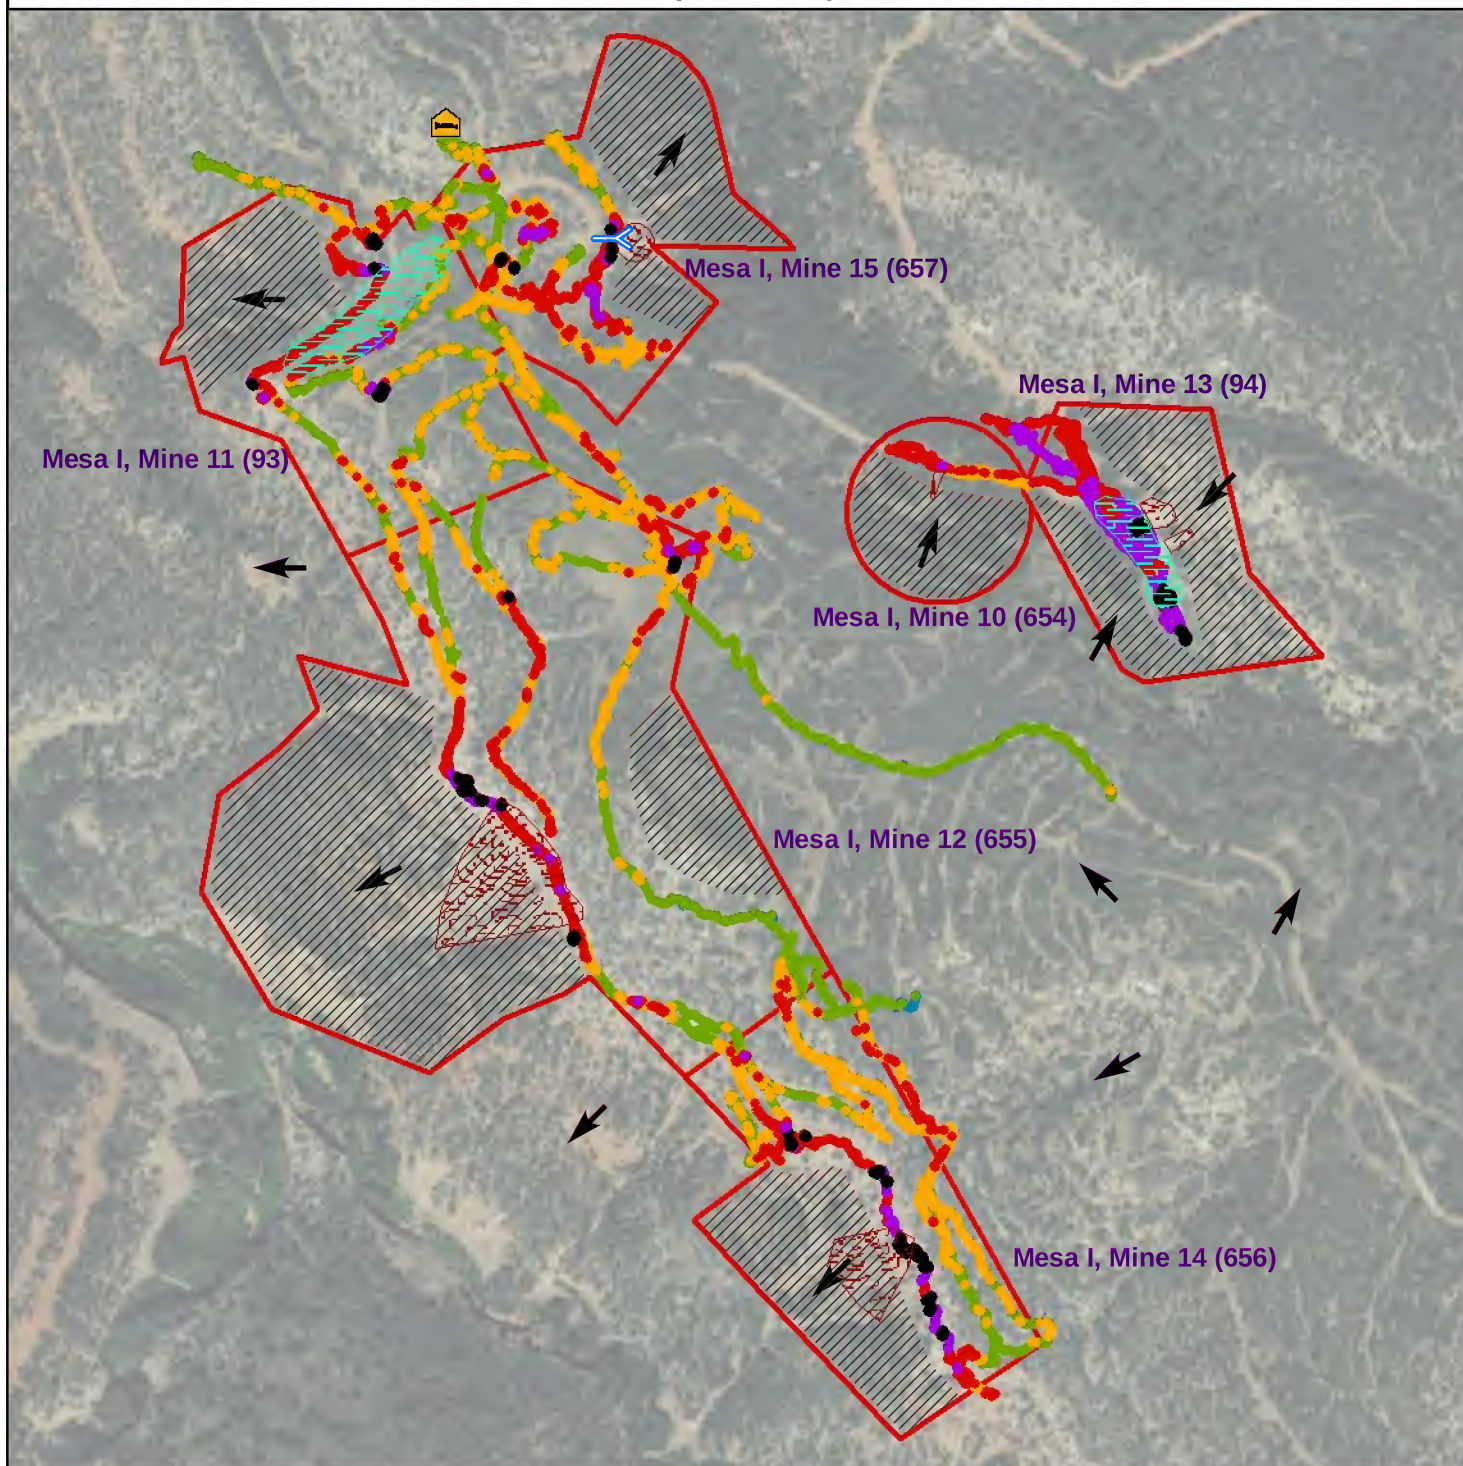
**Figure A-2 - Gamma Radiation Measurements**  
**Mesa I, Mine No. 10 - 15 (93, 94, 654, 655, 656, 657)**  
**Cove Chapter, Navajo Nation**

Gamma survey conducted 06/2010  
 Measured as counts per minute (cpm)  
 Average background 14,348 cpm
